**Flood Control Project Maintenance
Levee Inspections**

Fall 2015 Levee Maintenance Deficiency Summary Report

Sacramento River Basin

Reclamation District No. 0501 Ryer Island

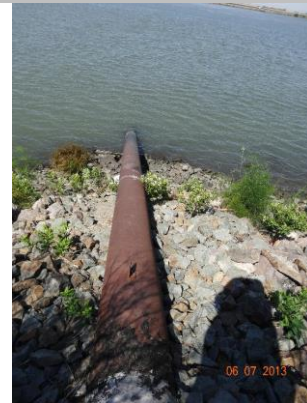
Photo 2 of 3 : UCIP_FA_2015_3901.jpg

Photo of pipe looking from berm edge to river edge.

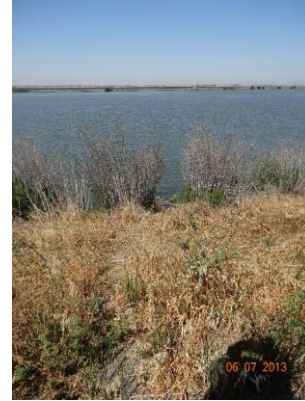
Photo 3 of 3 : UCIP_FA_2015_3902.jpg

LM Start	1.70	Rating **	M	Issue No.	35 (cont)
LM End	1.70	Issue Type +	En	Location *	WS
Category	Supplemental			GPS Latitude/Longitude	
				Start	End
Item	DWR UCIP Field Study			38.207507 °	38.207507 °
				-121.656219 °	-121.656219 °
DWR ID					
Action/Comments					
Inspector Comments: FS_ID:44867					
DS_ID:21093					
EP_NO: 13520					
FS_HLM: 1.7					
Repair Type: Non-Urgent					
Crossing Status: Found

Overview of waterside. Dense vegetation.

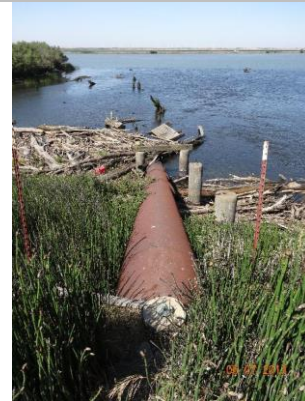
Photo 1 of 3 : UCIP_FA_2015_1735.jpg

LM Start	1.80	Rating **	M	Issue No.	36
LM End	1.80	Issue Type +	En	Location *	WS
Category	Supplemental			GPS Latitude/Longitude	
				Start	End
Item	DWR UCIP Field Study			38.208874 °	38.208874 °
				-121.655505 °	-121.655505 °
DWR ID					
Action/Comments					
Inspector Comments: FS_ID:40489 DS_ID:21042 EP_NO: 15477 FS_HLM: 1.81 Repair Type: Non-Urgent Crossing Status: Found UCIP Comments: Stacey Boyd, LMA superintendent for RD0501, confirmed the removal and replacement of existing crossing under new permit no. 18811. New crossing will be a 30-inch diameter discharge pipe above the design flood plane. Construction will start soon. Update record once the project is completed. Dense vegetation on both waterside and landside. Recommend removing vegetation along pipe alignment to conduct proper inspection of structure and appurtenances. FIELD_STRUCT_DESC: 42-inch steel pipe through the levee, 6.5 feet below the crown. Siphon breaker on waterward slope. Pump on the landward side (Permit No. 15477, 1990). Pipe exposed along both slopes. (USACE-1959). This entry matches the Drainage or Irrigation Structure referenced in O&M manual (HLM 2.0). FS Date: 06/07/2013

Siphon breaker on apex of steel pipe waterside.

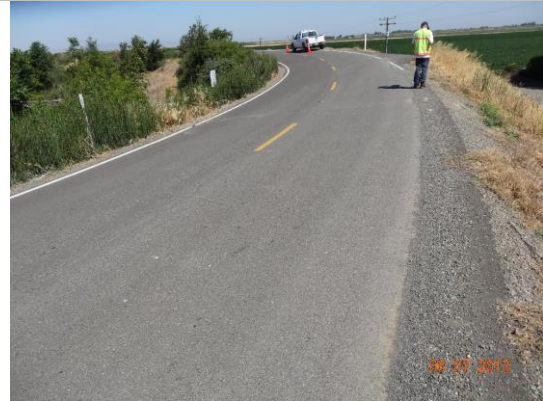
Photo 2 of 3 : UCIP_FA_2015_1736.jpg

Action/Comments					
Inspector Comments: FS_ID:40489 DS_ID:21042 EP_NO: 15477 FS_HLM: 1.81 Repair Type: Non-Urgent Crossing Status: Found UCIP Comments: Stacey Boyd, LMA superintendent for RD0501, confirmed the removal and replacement of existing crossing under new permit no. 18811. New crossing will be a 30-inch diameter discharge pipe above the design flood plane. Construction will start soon. Update record once the project is completed. Dense vegetation on both waterside and landside. Recommend removing vegetation along pipe alignment to conduct proper inspection of structure and appurtenances. FIELD_STRUCT_DESC: 42-inch steel pipe through the levee, 6.5 feet below the crown. Siphon breaker on waterward slope. Pump on the landward side (Permit No. 15477, 1990). Pipe exposed along both slopes. (USACE-1959). This entry matches the Drainage or Irrigation Structure referenced in O&M manual (HLM 2.0). FS Date: 06/07/2013

Overview of crown, looking downstream.

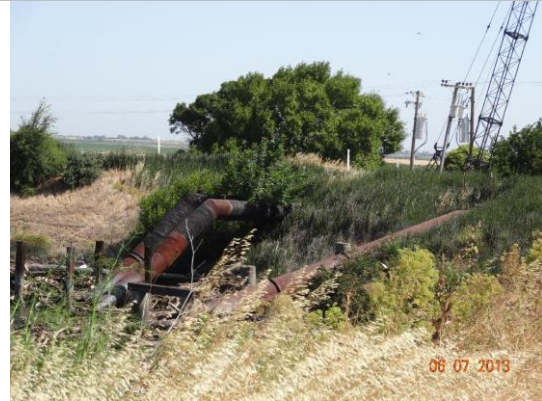
Photo 3 of 3 : UCIP_FA_2015_1737.jpg

LM Start	1.80	Rating **	M	Issue No.	36 (cont)	
LM End	1.80	Issue Type +	En	Location *	WS	
Category	Supplemental			GPS Latitude/Longitude		
				Start	End	
Item	DWR UCIP Field Study			38.208874 °	38.208874 °	
				-121.655505 °	-121.655505 °	
DWR ID						
Action/Comments						
Inspector Comments: FS_ID:40489 DS_ID:21042 EP_NO: 15477 FS_HLM: 1.81 Repair Type: Non-Urgent Crossing Status: Found UCIP Comments: Stacey Boyd, LMA superintendent for RD0501, confirmed the removal and replacement of existing crossing under new permit no. 18811. New crossing will be a 30-inch diameter discharge pipe above the design flood plane. Construction will start soon. Update record once the project is completed. Dense vegetation on both waterside and landside. Recommend removing vegetation along pipe alignment to conduct proper inspection of structure and appurtenances. FIELD_STRUCT_DESC: 42-inch steel pipe through the levee, 6.5 feet below the crown. Siphon breaker on waterward slope. Pump on the landward side (Permit No. 15477, 1990). Pipe exposed along both slopes. (USACE-1959). This entry matches the Drainage or Irrigation Structure referenced in O&M manual (HLM 2.0). FS Date: 06/07/2013

One 42-inch steel pile with siphon break on waterside slope.

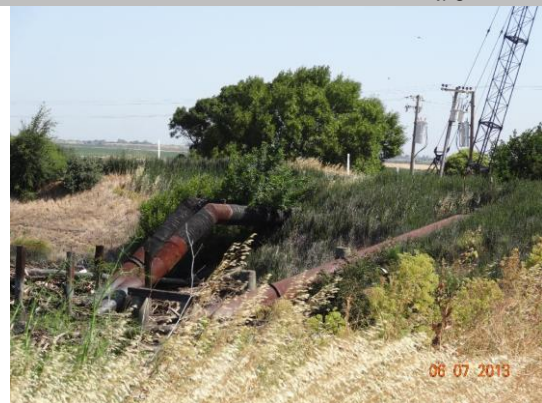
Photo 1 of 3 : UCIP_FA_2015_1852.jpg

LM Start	1.81	Rating **	M	Issue No.	37
LM End	1.81	Issue Type +	En	Location *	WS
Category	Supplemental			GPS Latitude/Longitude	
				Start	End
Item	DWR UCIP Field Study			38.208998 °	38.208998 °
				-121.655575 °	-121.655575 °
DWR ID					
Action/Comments					
Inspector Comments: FS_ID:19653 DS_ID:21091 EP_NO: 15477 FS_HLM: 1.817 Repair Type: Non-Urgent Crossing Status: Found UCIP Comments: Dense vegetation limits the inspector's visibility to identify signs of pipe failure (leaks) through the slope. Recommend removing vegetation along pipe alignment to conduct proper inspection of structure and appurtenances. FIELD_STRUCT_DESC: 2 of 2: 36-inch steel pipe through the levee, 7.0 feet below the crown. Siphon breaker on waterward shoulder. Pumps on landward side. Pipe exposed along both slopes. Pipe supports at levee shoulders, were cutoff walls from pre-existing pipe (Permit No. 15477-1990) Dual 36-inch pipes are approximately 36-inches apart. FS Date: 06/07/2013

Overview of dual pipes on waterward side.

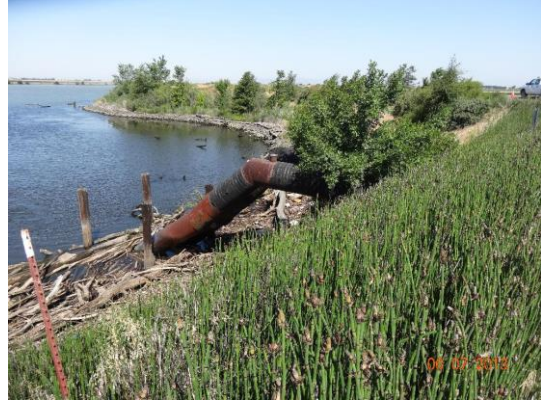
Photo 2 of 3 : UCIP_FA_2015_1853.jpg

View of exposed pipe section on waterward side.

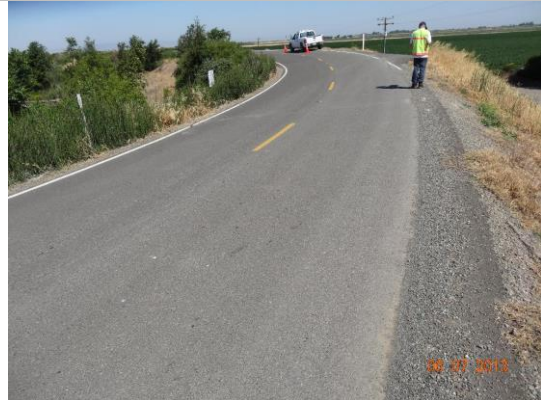
Photo 3 of 3 : UCIP_FA_2015_1854.jpg

Overview of crown, looking downstream

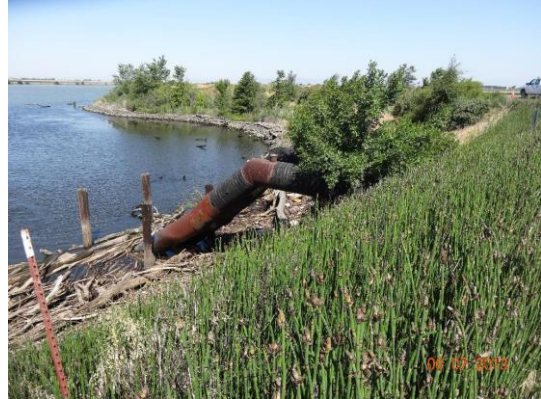
Photo 1 of 3 : UCIP_FA_2015_1824.jpg

LM Start	1.82	Rating **	M	Issue No.	38
LM End	1.82	Issue Type +	En	Location *	WS
Category	Supplemental			GPS Latitude/Longitude	
				Start	End
Item	DWR UCIP Field Study			38.209009 °	38.209009 °
				-121.655585 °	-121.655585 °
DWR ID					
Action/Comments					
Inspector Comments: FS_ID:19652					
DS_ID:21084					
EP_NO: 15477					
FS_HLM: 1.82					
Repair Type: Non-Urgent					
Crossing Status: Found

View of 36 inch pipes exposed on waterward side.

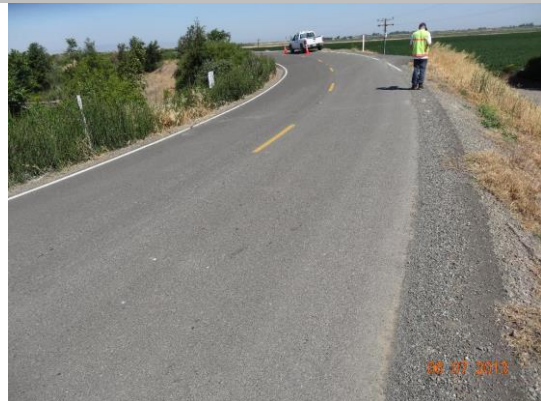
Photo 2 of 3 : UCIP_FA_2015_1825.jpg

Overview of levee crown at crossing.

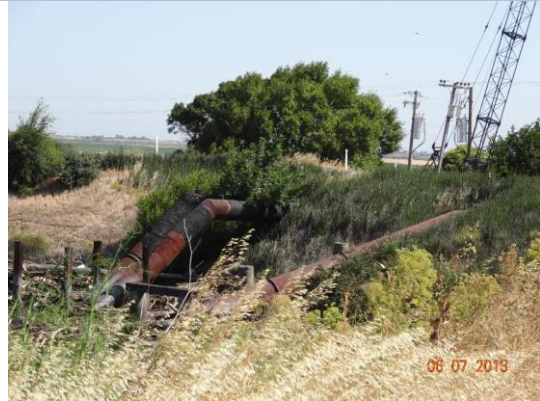
Photo 3 of 3 : UCIP_FA_2015_1826.jpg

LM Start	1.82	Rating **	M	Issue No.	38 (cont)
LM End	1.82	Issue Type +	En	Location *	WS
Category	Supplemental			GPS Latitude/Longitude	
				Start	End
Item	DWR UCIP Field Study			38.209009 °	38.209009 °
				-121.655585 °	-121.655585 °
DWR ID					
Action/Comments					
Inspector Comments: FS_ID:19652					
DS_ID:21084					
EP_NO: 15477					
FS_HLM: 1.82					
Repair Type: Non-Urgent					
Crossing Status: Found

Overview of waterward side--3 crossings visible 1-42 inch pipe and 2-36 inch pipes.

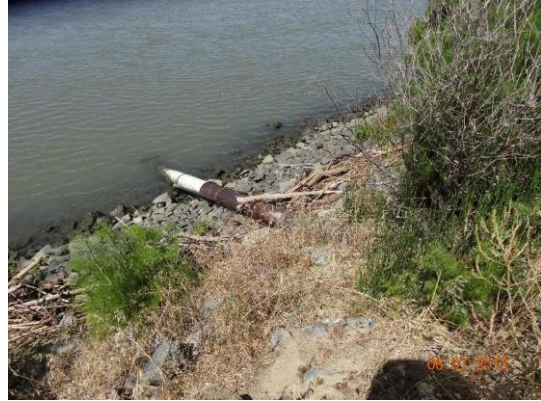
Photo 1 of 3 : UCIP_FA_2015_3903.jpg

Inspector Comments: FS_ID:32537
 DS_ID:21044
 EP_NO: N/A
 FS_HLM: 2.45
 Repair Type: Non-Urgent
 Crossing Status: Found
 UCIP Comments: Dense vegetation limits the inspector's visibility to identify signs of pipe failure (leaks) through the slope. Recommend removing vegetation along pipe alignment to conduct proper inspection of structure and appurtenances.
 FIELD_STRUCT_DESC: 14-inch steel pipe through the levee, 6.2 feet below the crown. Siphon breaker on waterward shoulder. (USACE-1959). This entry matches the Drainage or Irrigation Structure referenced in O&M manual (HLM 2.60). Pipe was repaired in 1984 under Permit No. 13937. The repair consisted of replacing the pipeline within the levee crown with new soil proofed steel pipe.
 FS Date: 06/07/2013

View of exposed section of pipe at waterward toe.

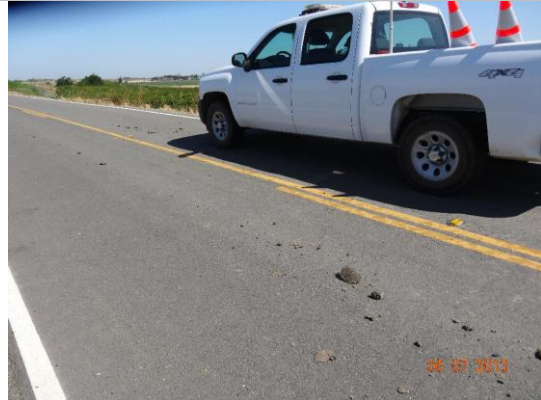
Photo 2 of 3 : UCIP_FA_2015_3904.jpg

View of levee crown--narrow road.

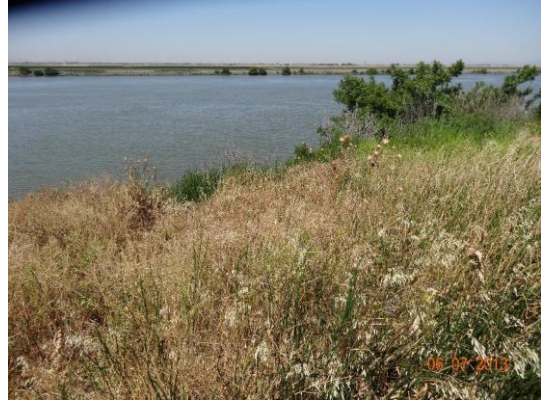
Photo 3 of 3 : UCIP_FA_2015_3905.jpg

Photo taken just downstream of crossing looking at waterward side.

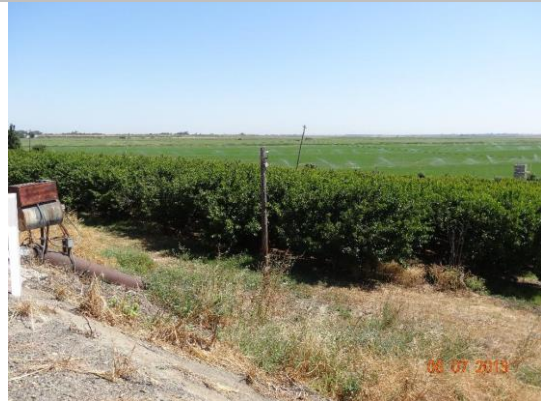
Photo 1 of 3 : UCIP_FA_2015_1855.jpg

LM Start	2.80	Rating **	M	Issue No.	40
LM End	2.80	Issue Type +	En	Location *	LS
Category	Supplemental			GPS Latitude/Longitude	
				Start	End
Item	DWR UCIP Field Study			38.217579 °	38.217579 °
				-121.668963 °	-121.668963 °
DWR ID					
Action/Comments					
Inspector Comments: FS_ID:44872 DS_ID:21045 EP_NO: 4733 FS_HLM: 2.81 Repair Type: Non-Urgent Crossing Status: Found UCIP Comments: Dense vegetation limits the inspector's visibility to identify signs of pipe failure (leaks) through the waterward slope. Recommend removing vegetation along pipe alignment to conduct proper inspection of structure and appurtenances. FIELD_STRUCT_DESC: 18-inch pipe through the levee, 4.0 feet below the crown. Cutoff wall around pipe at center of levee. Siphon breaker on apex of pipe at landward shoulder. Rock revetment on waterward slope. 16-inch pipe welded to 18-inch pipe near landward shoulder, extends down landward slope. Pipe exposed along both slopes. (Permit No. 4733-1964) FS Date: 06/07/2013

Overview of landward side. Pump system located near crown hinge point.

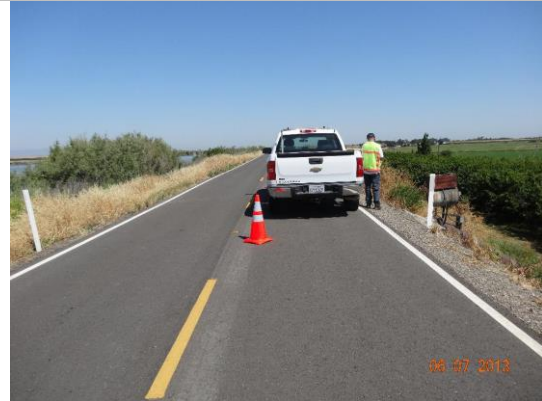
Photo 2 of 3 : UCIP_FA_2015_1856.jpg

View of levee crown at crossing.

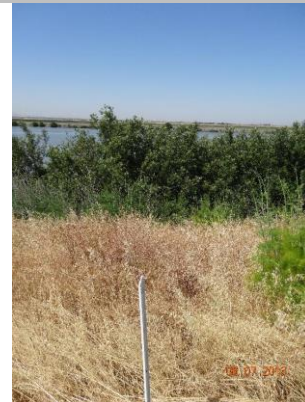
Photo 3 of 3 : UCIP_FA_2015_1857.jpg

Dense vegetation hindered inspection on waterward side.

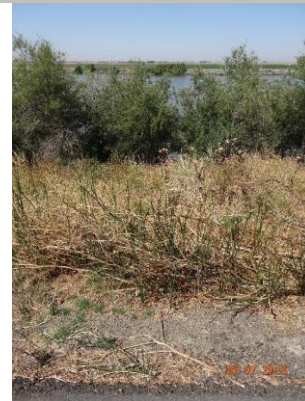
Photo 1 of 3 : UCIP_FA_2015_1858.jpg

LM Start	3.07	Rating **	M	Issue No.	41
LM End	3.07	Issue Type +	En	Location *	LS
Category	Supplemental			GPS Latitude/Longitude	
				Start	End
Item	DWR UCIP Field Study			38.221090 °	38.221090 °
				-121.671384 °	-121.671384 °
DWR ID					
Action/Comments					
Inspector Comments: FS_ID:19657 DS_ID:21046 EP_NO: N/A FS_HLM: 3.087 Repair Type: Non-Urgent Crossing Status: Found UCIP Comments: Dense vegetation limits the inspector's visibility to identify signs of pipe failure (leaks) through the waterward slope. Recommend removing vegetation along pipe alignment to conduct proper inspection of structure and appurtenances. FIELD_STRUCT_DESC: 16-inch pipe sleeved through a 20-inch pipe through the levee, 4.7 feet below the crown. Annular gap grouted. Siphon breaker on landward shoulder. Pipe exposed along both slopes. (USACE-1959). This entry matches the Drainage or Irrigation Structure referenced in O&M manual (HLM 3.30). The 16-inch pipe was sleeved through pre-existing pipe under Permit No. 2645 (1959). FS Date: 08/22/2013

Dense vegetation along the crown hinge point and beginning section of waterward slope.

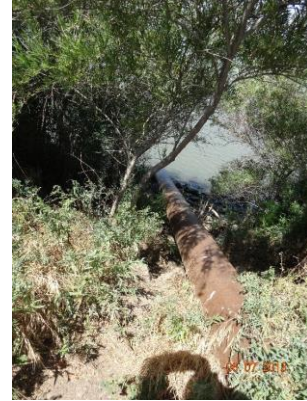
Photo 2 of 3 : UCIP_FA_2015_1859.jpg

Overview of pipe along waterward side.

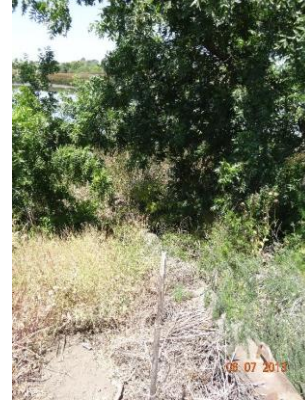
Photo 1 of 3 : UCIP_FA_2015_1861.jpg

LM Start	0.62	Rating **	M	Issue No.	132
LM End	0.62	Issue Type +	En	Location *	WS
Category	Supplemental			GPS Latitude/Longitude	
				Start	End
Item	DWR UCIP Field Study			38.234679 °	38.234679 °
				-121.665417 °	-121.665417 °
DWR ID					
Action/Comments					
Inspector Comments: FS_ID:44873 DS_ID:21065 EP_NO: N/A FS_HLM: 0.647 Repair Type: Non-Urgent Crossing Status: Found UCIP Comments: Pump operating during inspection. Need to determine owner. Dense vegetation limits the inspector's visibility to identify signs of pipe failure (leaks) through the waterward slope. Recommend removing vegetation along pipe alignment to conduct proper inspection of structure and appurtenances. FIELD_STRUCT_DESC: 14-inch steel pipe through the levee, 6.3 feet below the crown instead of 16-inch pipe mentioned in O&M. Siphon breaker on landward slope. Pipe exposed on both slopes. (USACE-1959). This entry matches the Drainage or Irrigation Structure referenced in O&M manual (HLM 0.70). FS Date: 06/07/2013

Conditions of waterward slope--dense vegetation along slope.

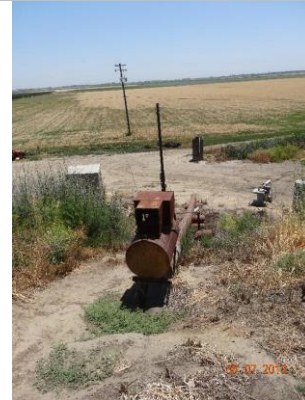
Photo 2 of 3 : UCIP_FA_2015_1946.jpg

Overview of landward side--pump sytem, pipe, and standpipe.

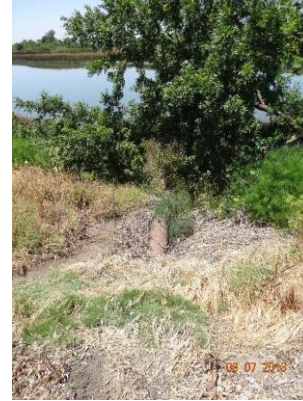
Photo 3 of 3 : UCIP_FA_2015_1947.jpg

Overview of waterward side. Dense vegetation limits proper inspection.

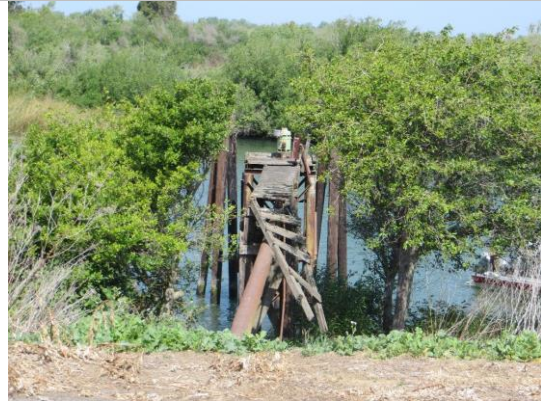
Photo 1 of 2 : UCIP_FA_2015_6231.jpg

Inspector Comments: FS_ID:44728
 DS_ID:21066
 EP_NO: N/A
 FS_HLM: 1.38
 Repair Type: Non-Urgent
 Crossing Status: Found
 UCIP Comments: Pipe appears abandoned and if so should be done so properly. Wooden walkway to pier in disrepair and a hazard.
 FIELD_STRUCT_DESC: 12-inch steel irrigation pipe through the levee, 8.0-feet below the crown. Siphon breaker on landward slope. Pump on pipe structure in stream. Concrete standpipe and distribution slide gates at landward toe. (USACE-1959). This entry matches the Drainage or Irrigation Structure referenced in O&M manual (HLM 1.50). 1.5-inch electrical conduit at same location.
 FS Date: 06/07/2013

Pump on wooden pier off WS toe.

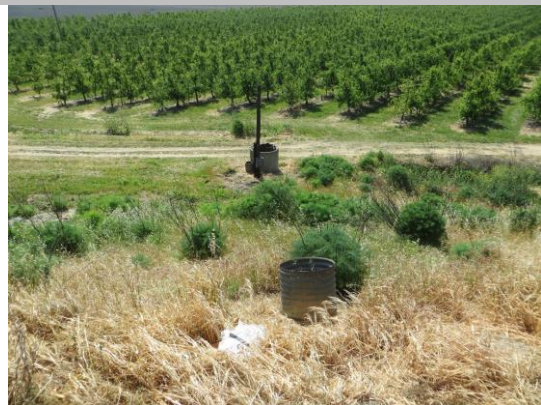
Photo 2 of 2 : UCIP_FA_2015_6232.jpg

Siphon breaker in 24-inch CMP riser on LS slope. Standpipe visible at LS toe.

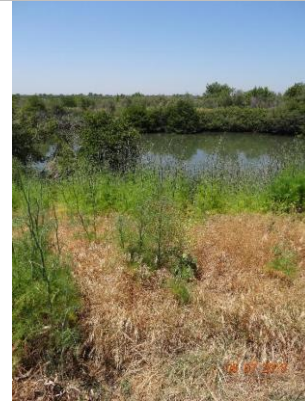
Photo 1 of 2 : UCIP_FA_2015_1962.jpg

LM Start	1.88	Rating **	M	Issue No.	134
LM End	1.88	Issue Type +	En	Location *	WS
Category	Supplemental			GPS Latitude/Longitude	
				Start	End
Item	DWR UCIP Field Study			38.249362 °	38.249362 °
				-121.656357 °	-121.656357 °
DWR ID					
Action/Comments					
Inspector Comments: FS_ID:43503 DS_ID:21068 EP_NO: N/A FS_HLM: 1.93 Repair Type: Non-Urgent Crossing Status: Found UCIP Comments: Authorized or Unauthorized? Need permit authorizing work. Dense vegetation limits the inspector's visibility to identify signs of pipe failure (leaks) through the slope on both waterward and landward side. Recommend removing vegetation along pipe alignment to conduct proper inspection of structure and appurtenances. FIELD_STRUCT_DESC: 10-inch steel pipe through the levee, 6.3 feet below the crown. Pump, gate valve and switch box on waterward slope. Originally reported as 3.8-feet below crown in O+M manual, 1959 at HLM: 2.0. FS Date: 06/07/2013

Overview of waterward side. Pipe is completely obstructed by dense vegetation.

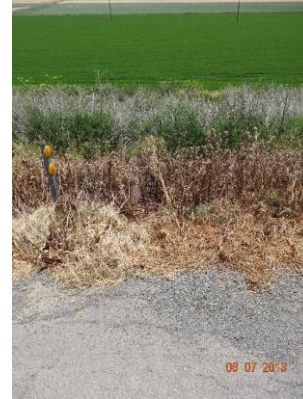
Photo 2 of 2 : UCIP_FA_2015_1963.jpg

Overview of landward side. Pipe is visible however dense vegetation limits proper inspection.

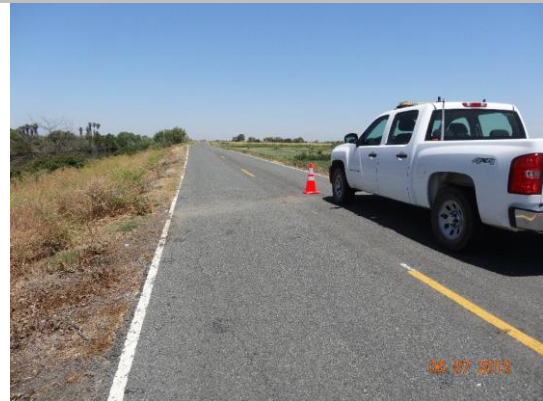
Photo 1 of 3 : UCIP_FA_2015_1619.jpg

LM Start	2.52	Rating **	M	Issue No.	135
LM End	2.52	Issue Type +	En	Location *	WS
Category	Supplemental			GPS Latitude/Longitude	
				Start	End
Item	DWR UCIP Field Study			38.256255 °	38.256255 °
				-121.651551 °	-121.651551 °
DWR ID					
Action/Comments					
Inspector Comments: FS_ID:18945 DS_ID:21047 EP_NO: N/A FS_HLM: 2.573 Repair Type: Non-Urgent Crossing Status: Found UCIP Comments: Need to determine owner of structure. Recommend removing vegetation along pipe alignment to conduct proper inspection of structure and appurtenances. FIELD_STRUCT_DESC: 16-inch steel pipe through the levee, 3.3 feet below the crown. Gate valve and switch box on landward slope. Pipe exposed on both slopes. (USACE-1959) Riprap on waterward side. This entry matches the Drainage or Irrigation Structure referenced in O&M manual (HLM 2.70). FS Date: 06/07/2013

Overview of levee crown at crossing.

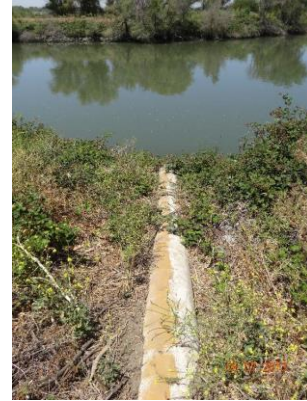
Photo 2 of 3 : UCIP_FA_2015_1620.jpg

Inspector Comments: FS_ID:18945
 DS_ID:21047
 EP_NO: N/A
 FS_HLM: 2.573
 Repair Type: Non-Urgent
 Crossing Status: Found
 UCIP Comments: Need to determine owner of structure. Recommend removing vegetation along pipe alignment to conduct proper inspection of structure and appurtenances.
 FIELD_STRUCT_DESC: 16-inch steel pipe through the levee, 3.3 feet below the crown. Gate valve and switch box on landward slope. Pipe exposed on both slopes. (USACE-1959) Riprap on waterward side. This entry matches the Drainage or Irrigation Structure referenced in O&M manual (HLM 2.70).
 FS Date: 06/07/2013

Exposed section of pipe located on waterward side.

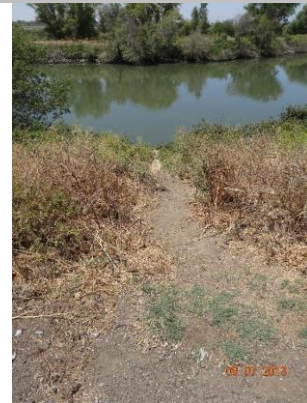
Photo 3 of 3 : UCIP_FA_2015_1630.jpg

Overview of waterward side. Pipe is mostly buried through waterward side.

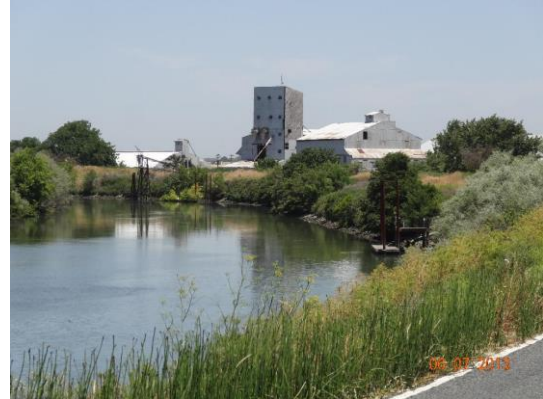
Photo 1 of 2 : UCIP_FA_2015_3906.jpg

LM Start	3.51	Rating **	M	Issue No.	136
LM End	3.51	Issue Type +	En	Location *	LS
Category	Supplemental			GPS Latitude/Longitude	
				Start	End
Item	DWR UCIP Field Study			38.266187 °	38.266187 °
				-121.641909 °	-121.641909 °
DWR ID					
Action/Comments					
Inspector Comments: FS_ID:32538 DS_ID:21048 EP_NO: N/A FS_HLM: 3.58 Repair Type: Non-Urgent Crossing Status: Found UCIP Comments: Dense vegetation limits the inspector's visibility to identify signs of pipe failure (leaks) through the waterward slope. Recommend removing vegetation along pipe alignment to conduct proper inspection of structure and appurtenances. Need to find owner of crossing and determine if permit number is available. FIELD_STRUCT_DESC: 12-inch steel pipe through the levee, 5.0 feet below the crown. Pump on pile structure in stream. Service pole on landward slope. Concrete standpipe at landward toe. (USACE-1959). This entry matches the Drainage or Irrigation Structure referenced in O&M manual (HLM 3.80). FS Date: 06/07/2013

Photo taken downstream of structure.

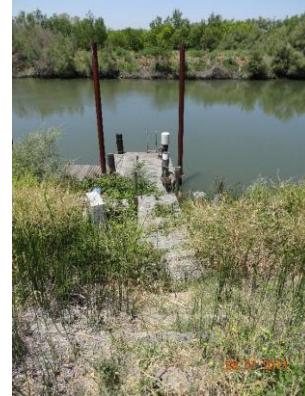
Photo 2 of 2 : UCIP_FA_2015_3994.jpg

View of waterward side. Dense vegetation throughout waterward side.
Walkway visible and support piles.

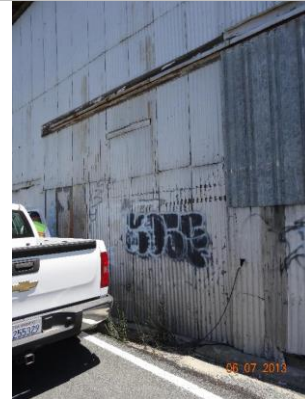
Photo 1 of 3 : UCIP_FA_2015_3722.jpg

LM Start	3.65	Rating **	M	Issue No.	138
LM End	3.65	Issue Type +	En	Location *	LS
Category	Supplemental			GPS Latitude/Longitude	
				Start	End
Item	DWR UCIP Field Study			38.267818 °	38.267818 °
				-121.640521 °	-121.640521 °
DWR ID					
Action/Comments					
Inspector Comments: FS_ID:32540 DS_ID:21050 EP_NO: N/A FS_HLM: 3.716 Repair Type: Non-Urgent Crossing Status: Found UCIP Comments: Unable to properly inspect structure--limited access. Also unable to determine if structure is still in use. Levee logs indicate this crossing is abandoned. If structure is no longer used-how to prevent water from flowing through levee during flood season. If structure no longer in use owner will need to coordinate with CVFPB. FIELD_STRUCT_DESC: Abandoned 5.5 x 5.5 foot concrete tunnel through the levee, 6.5 feet below the crown. FS Date: 06/07/2013

View of large building structure located on landward side.

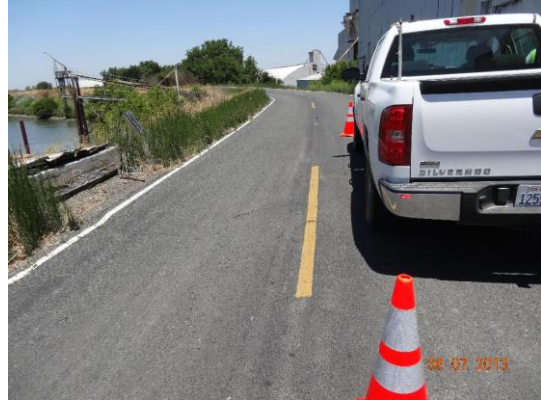
Photo 2 of 3 : UCIP_FA_2015_3723.jpg

View of narrow levee crown.

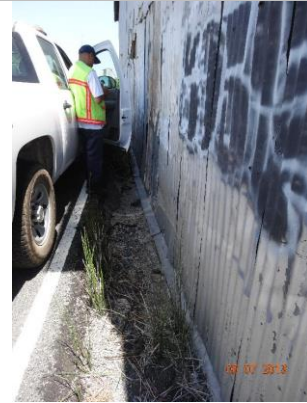
Photo 3 of 3 : UCIP_FA_2015_3995.jpg

View of structure on landward side.

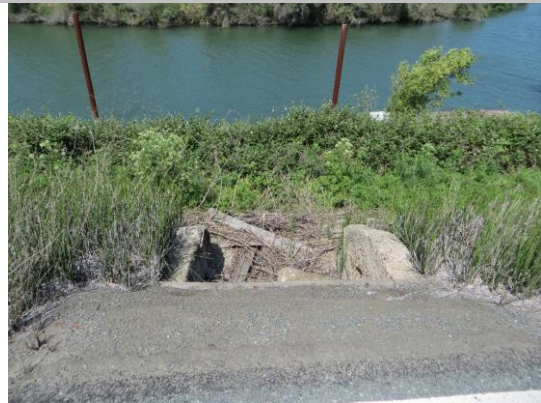
Photo 2 of 3 : UCIP_FA_2015_5511.jpg

LM Start	3.66	Rating **	U	Issue No.	139
LM End	3.66	Issue Type +	En	Location *	LS
Category	Supplemental			GPS Latitude/Longitude	
				Start	End
Item	DWR UCIP Field Study			38.268003 °	38.268003 °
				-121.640474 °	-121.640474 °
DWR ID					
Action/Comments					
Inspector Comments: FS_ID:44743 DS_ID:21051 EP_NO: N/A FS_HLM: 3.729 Repair Type: Urgent Crossing Status: Found

Concrete tunnel and wingwalls visible on WS slope.

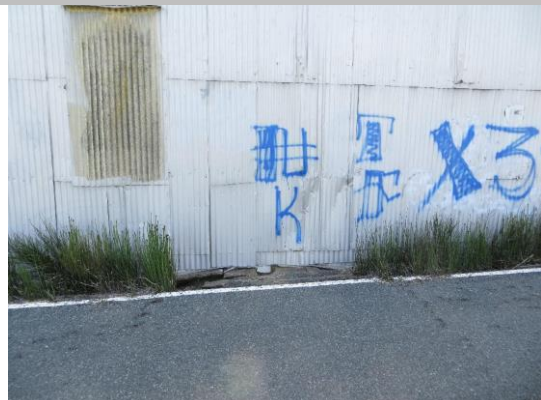
Photo 3 of 3 : UCIP_FA_2015_5512.jpg

Building on LS shoulder prevents access to LS of levee.

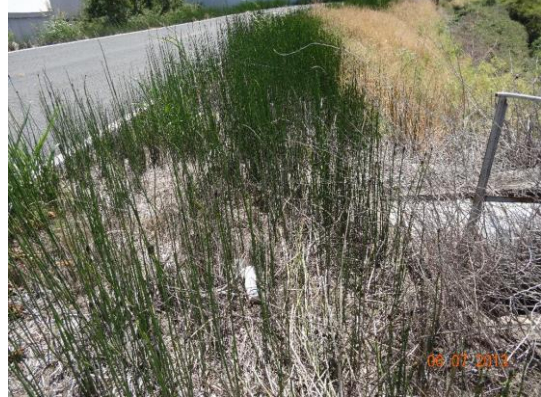
Photo 1 of 3 : UCIP_FA_2015_1964.jpg

LM Start	3.68	Rating **	M	Issue No.	140
LM End	3.68	Issue Type +	En	Location *	LS
Category	Supplemental			GPS Latitude/Longitude	
				Start	End
Item	DWR UCIP Field Study			38.268278 °	38.268278 °
				-121.640377 °	-121.640377 °
DWR ID					
Action/Comments					
Inspector Comments: FS_ID:19662					
DS_ID:21052					
EP_NO: N/A					
FS_HLM: 3.748					
Repair Type: Non-Urgent					
Crossing Status: Found

Dense vegetation along the pipe alignment and throughout waterward slope.

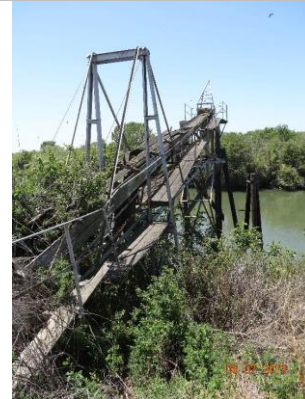
Photo 2 of 3 : UCIP_FA_2015_1965.jpg

Reminiscence of grain loading auger located on waterward slope.

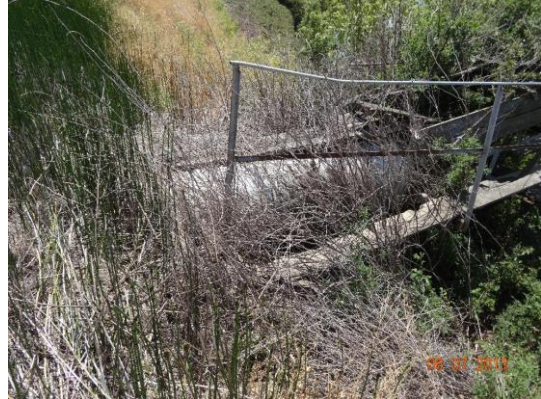
Photo 3 of 3 : UCIP_FA_2015_1966.jpg

LM Start	3.68	Rating **	M	Issue No.	140 (cont)
LM End	3.68	Issue Type +	En	Location *	LS
Category	Supplemental			GPS Latitude/Longitude	
				Start	End
Item	DWR UCIP Field Study			38.268278 °	38.268278 °
				-121.640377 °	-121.640377 °
DWR ID					
Action/Comments					
Inspector Comments: FS_ID:19662 DS_ID:21052 EP_NO: N/A FS_HLM: 3.748 Repair Type: Non-Urgent Crossing Status: Found

View of waterward side. Pipe visible through dense vegetation.

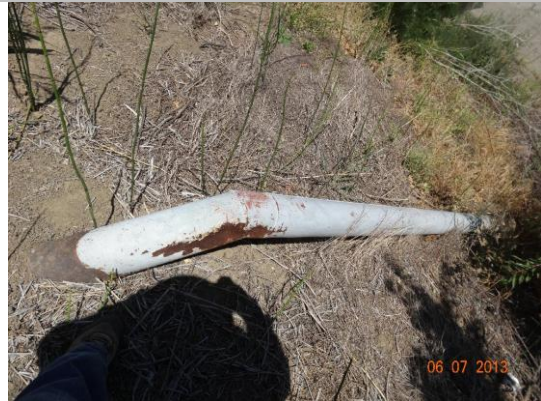
Photo 1 of 3 : UCIP_FA_2015_1967.jpg

LM Start	3.70	Rating **	M	Issue No.	141
LM End	3.70	Issue Type +	En	Location *	LS
Category	Supplemental			GPS Latitude/Longitude	
				Start	End
Item	DWR UCIP Field Study			38.268570 °	38.268570 °
				-121.640408 °	-121.640408 °
DWR ID					
Action/Comments					
Inspector Comments: FS_ID:43524					
DS_ID:21053					
EP_NO: N/A					
FS_HLM: 3.77					
Repair Type: Non-Urgent					
Crossing Status: Found					
UCIP Comments: Dense vegetation limits the inspector's visibility to identify signs of pipe failure (leaks) through the waterward slope.					
Recommend removing vegetation along pipe alignment to conduct proper inspection of structure and appurtenances.					
FIELD_STRUCT_DESC: 6-inch pipe through the levee, 2.5 feet below the crown. Pump in pump house on waterward slope. (USACE-1959).					
This entry matches the Drainage or Irrigation Structure referenced in O&M manual (HLM 4.00). (Permit No. 1557, 1951).

Close up of pipe along landward side.

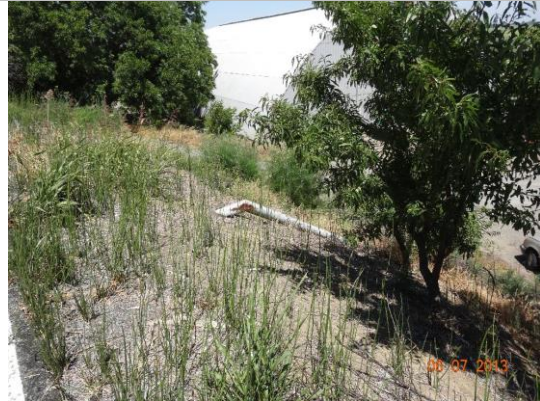
Photo 2 of 3 : UCIP_FA_2015_1968.jpg

Inspector Comments: FS_ID:43524
 DS_ID:21053
 EP_NO: N/A
 FS_HLM: 3.77
 Repair Type: Non-Urgent
 Crossing Status: Found
 UCIP Comments: Dense vegetation limits the inspector's visibility to identify signs of pipe failure (leaks) through the waterward slope. Recommend removing vegetation along pipe alignment to conduct proper inspection of structure and appurtenances.
 FIELD_STRUCT_DESC: 6-inch pipe through the levee, 2.5 feet below the crown. Pump in pump house on waterward slope. (USACE-1959). This entry matches the Drainage or Irrigation Structure referenced in O&M manual (HLM 4.00). (Permit No. 1557, 1951).
 FS Date: 06/07/2013

View of landward side. Pipe visible.

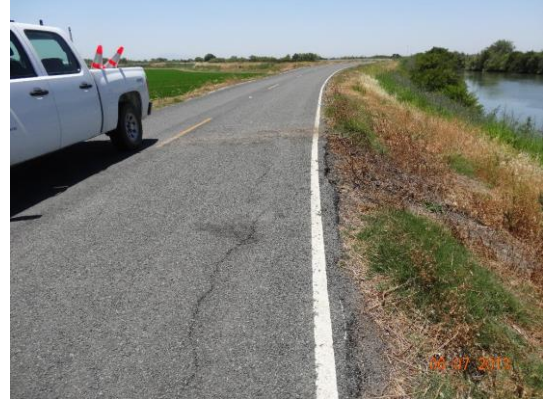
Photo 1 of 3 : UCIP_FA_2015_1970.jpg

LM Start	4.30	Rating **	M	Issue No.	142
LM End	4.30	Issue Type +	En	Location *	LS
Category	Supplemental			GPS Latitude/Longitude	
				Start	End
Item	DWR UCIP Field Study			38.275862 °	38.275862 °
				-121.638709 °	-121.638709 °
DWR ID					
Action/Comments					
Inspector Comments: FS_ID:44876					
DS_ID:21069					
EP_NO: N/A					
FS_HLM: 4.387					
Repair Type: Non-Urgent					
Crossing Status: Found

Line cracks along crown near crown hinge point on waterward side.

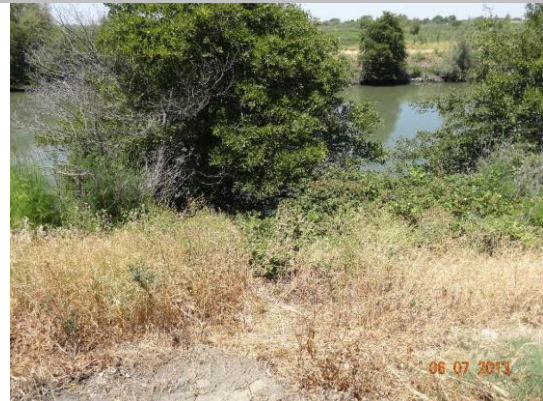
Photo 2 of 3 : UCIP_FA_2015_1971.jpg

View of waterward slope. Dense vegetation along slope.

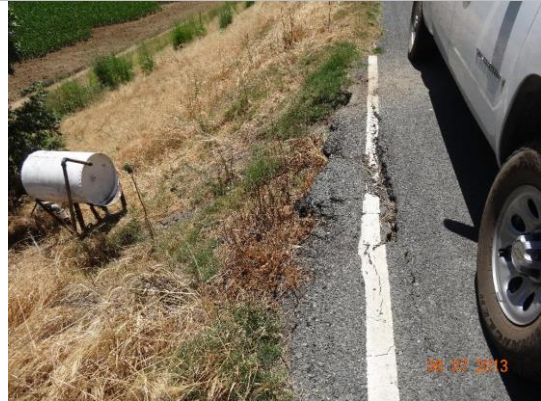
Photo 3 of 3 : UCIP_FA_2015_1972.jpg

LM Start	4.30	Rating **	M	Issue No.	142 (cont)
LM End	4.30	Issue Type +	En	Location *	LS
Category	Supplemental			GPS Latitude/Longitude	
				Start	End
Item	DWR UCIP Field Study			38.275862 °	38.275862 °
				-121.638709 °	-121.638709 °
DWR ID					
Action/Comments					
Inspector Comments: FS_ID:44876					
DS_ID:21069					
EP_NO: N/A					
FS_HLM: 4.387					
Repair Type: Non-Urgent					
Crossing Status: Found

View of landward side. Dry vegetation covers landward slope. Pump system located on landward slope.

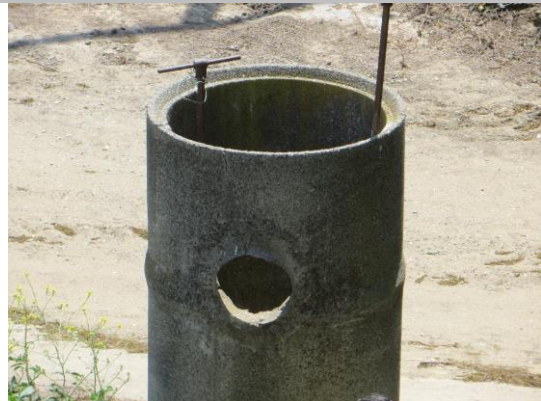
Photo 1 of 2 : UCIP_FA_2015_6254.jpg

LM Start	4.31	Rating **	M	Issue No.	143
LM End	4.31	Issue Type +	En	Location *	LS
Category	Supplemental			GPS Latitude/Longitude	
				Start	End
Item	DWR UCIP Field Study			38.275955 °	38.275955 °
				-121.638626 °	-121.638626 °
DWR ID					
Action/Comments					
Inspector Comments: FS_ID:44746 DS_ID:21107 EP_NO: N/A FS_HLM: 4.39 Repair Type: Non-Urgent Crossing Status: Indicator Found UCIP Comments: Need to verify type of abandonment. FIELD_STRUCT_DESC: *ABANDONED* 10-inch pipe through the levee, 4.8 feet below the crown. 34-inch concrete standpipe on LS toe. 10-inch diameter hole in standpipe where abandoned pipe once connected (USACE-1959). This entry matches the Drainage or Irrigation Structure referenced in O&M manual (HLM 4.60). FS Date: 04/23/2015

10-inch diameter hole cut in side of standpipe where pipe once was installed.

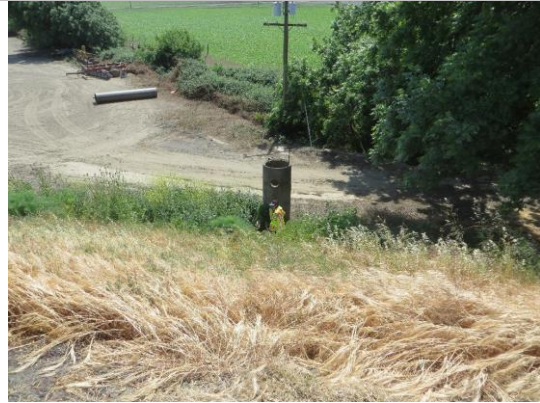
Photo 2 of 2 : UCIP_FA_2015_6255.jpg

LM Start	4.31	Rating **	M	Issue No.	143 (cont)	
LM End	4.31	Issue Type +	En	Location *	LS	
Category	Supplemental			GPS Latitude/Longitude		
				Start	End	
Item	DWR UCIP Field Study			38.275955 °	38.275955 °	
				-121.638626 °	-121.638626 °	
DWR ID						
Action/Comments						
Inspector Comments: FS_ID:44746						
DS_ID:21107						
EP_NO: N/A						
FS_HLM: 4.39						
Repair Type: Non-Urgent						
Crossing Status: Indicator Found						
UCIP Comments: Need to verify type of abandonment.						
FIELD_STRUCT_DESC: *ABANDONED* 10-inch pipe through the						
levee, 4.8 feet below the crown. 34-inch concrete standpipe on LS toe.						
10-inch diameter hole in standpipe where abandoned pipe once						
connected (USACE-1959). This entry matches the Drainage or						
Irrigation Structure referenced in O&M manual (HLM 4.60).						
FS Date: 04/23/2015

34-inch diameter concrete standpipe at LS toe.

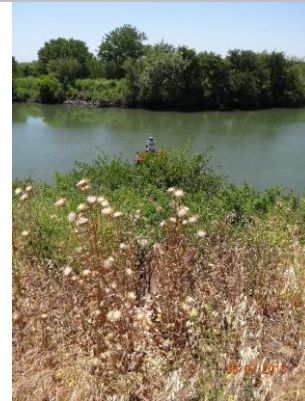
Photo 1 of 2 : UCIP_FA_2015_3124.jpg

LM Start	4.75	Rating **	M	Issue No.	144
LM End	4.75	Issue Type +	En	Location *	LS
Category	Supplemental			GPS Latitude/Longitude	
				Start	End
Item	DWR UCIP Field Study			38.281041 °	38.281041 °
				-121.640904 °	-121.640904 °
DWR ID					
Action/Comments					
Inspector Comments: FS_ID:32541 DS_ID:21071 EP_NO: N/A FS_HLM: 4.836 Repair Type: Non-Urgent Crossing Status: Found UCIP Comments: --Contact owner--Dense vegetation limits the inspector's visibility to identify signs of pipe failure (leaks) along the waterward and landward slopes. Recommend removing vegetation along pipe alignment to conduct proper inspection of structure and appurtances. Walkway and siphon breaker not found. FIELD_STRUCT_DESC: 12-inch concrete pipe through the levee, 2.5 feet below the crown. Cutoff wall around pipe at center of levee. Siphon breaker on apex of pipe at shoulder. Pump on pile structure in stream. Walkway access to pump. (USACE-1959). This entry matches the Drainage or Irrigation Structure referenced in O&M manual (HLM 5.10). FS Date: 06/07/2013

View of waterward side. Pump located on pile structure in stream.

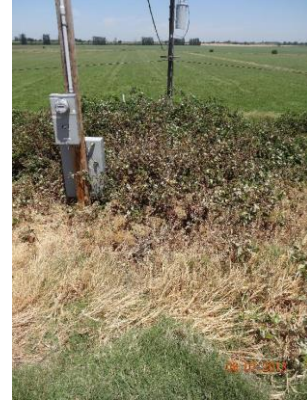
Photo 2 of 2 : UCIP_FA_2015_3125.jpg

Item	DWR UCIP Field Study			38.281041 °	38.281041 °	
				-121.640904 °	-121.640904 °	
DWR ID						
Action/Comments						
Inspector Comments: FS_ID:32541 DS_ID:21071 EP_NO: N/A FS_HLM: 4.836 Repair Type: Non-Urgent Crossing Status: Found UCIP Comments: --Contact owner--Dense vegetation limits the inspector's visibility to identify signs of pipe failure (leaks) along the waterward and landward slopes. Recommend removing vegetation along pipe alignment to conduct proper inspection of structure and appurtenances. Walkway and siphon breaker not found. FIELD_STRUCT_DESC: 12-inch concrete pipe through the levee, 2.5 feet below the crown. Cutoff wall around pipe at center of levee. Siphon breaker on apex of pipe at shoulder. Pump on pile structure in stream. Walkway access to pump. (USACE-1959). This entry matches the Drainage or Irrigation Structure referenced in O&M manual (HLM 5.10). FS Date: 06/07/2013

View of landward side. Power source and control box on landward side.

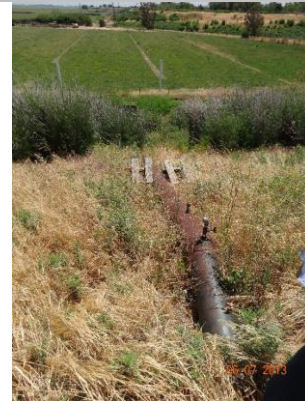
Photo 1 of 3 : UCIP_FA_2015_1973.jpg

LM Start	5.43	Rating **	M	Issue No.	146
LM End	5.43	Issue Type +	En	Location *	LS
Category	Supplemental			GPS Latitude/Longitude	
				Start	End
Item	DWR UCIP Field Study			38.288950 °	38.288950 °
				-121.644183 °	-121.644183 °
DWR ID					
Action/Comments					
Inspector Comments: FS_ID:19666 DS_ID:21054 EP_NO: N/A FS_HLM: 5.51 Repair Type: Non-Urgent Crossing Status: Found UCIP Comments: Need to find owner and permit number authorizing work. Dense vegetation limits the inspector's visibility to identify signs of pipe failure (leaks) along the waterward and landward slopes. Recommend removing vegetation along pipe alignment to conduct proper inspection of structure and appurtenances. FIELD_STRUCT_DESC: 12-inch pipe through the levee, 3.0 feet below the crown. Pump on pile structure in stream. FS Date: 06/07/2013

View of pipe on landward side. Dry vegetation covers landward slope.

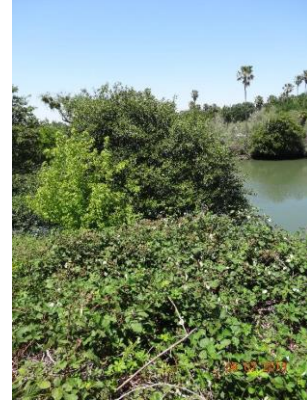
Photo 2 of 3 : UCIP_FA_2015_1974.jpg

LM Start	5.43	Rating **	M	Issue No.	146 (cont)	
LM End	5.43	Issue Type +	En	Location *	LS	
Category	Supplemental			GPS Latitude/Longitude		
				Start	End	
Item	DWR UCIP Field Study			38.288950 °	38.288950 °	
				-121.644183 °	-121.644183 °	
DWR ID						
Action/Comments						
Inspector Comments: FS_ID:19666 DS_ID:21054 EP_NO: N/A FS_HLM: 5.51 Repair Type: Non-Urgent Crossing Status: Found UCIP Comments: Need to find owner and permit number authorizing work. Dense vegetation limits the inspector's visibility to identify signs of pipe failure (leaks) along the waterward and landward slopes. Recommend removing vegetation along pipe alignment to conduct proper inspection of structure and appurtenances. FIELD_STRUCT_DESC: 12-inch pipe through the levee, 3.0 feet below the crown. Pump on pile structure in stream. FS Date: 06/07/2013

Structure visible through the dense vegetation. Limited access unable to inspect.

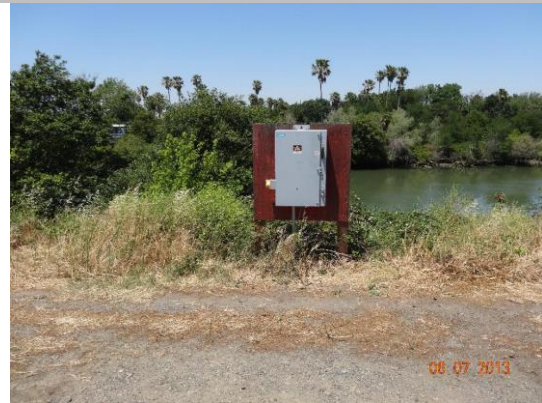
Photo 3 of 3 : UCIP_FA_2015_1975.jpg

Overview of waterward side. Control box located near levee crown.

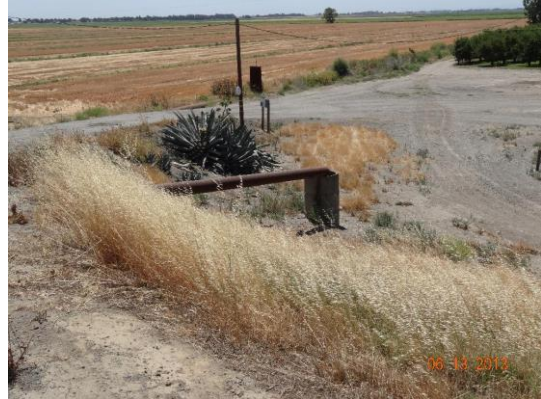
Photo 1 of 3 : UCIP_FA_2015_3126.jpg

LM Start	6.39	Rating **	M	Issue No.	147
LM End	6.39	Issue Type +	En	Location *	LS
Category	Supplemental			GPS Latitude/Longitude	
				Start	End
Item	DWR UCIP Field Study			38.290373 °	38.290373 °
				-121.627633 °	-121.627633 °
DWR ID					
Action/Comments					
Inspector Comments: FS_ID:32542					
DS_ID:21059					
EP_NO: N/A					
FS_HLM: 6.5					
Repair Type: Non-Urgent					
Crossing Status: Found

View of landward side. Pipe goes through levee and into concrete standpipe.

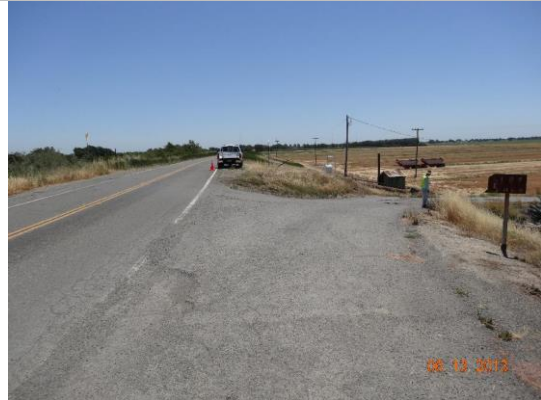
Photo 2 of 3 : UCIP_FA_2015_3127.jpg

Overview of levee crown at crossing.

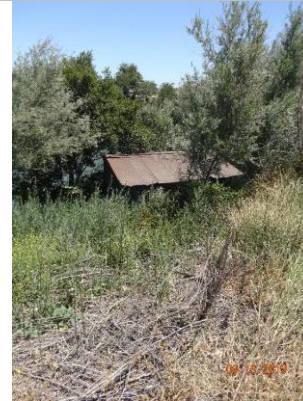
Photo 3 of 3 : UCIP_FA_2015_3128.jpg

LM Start	6.39	Rating **	M	Issue No.	147 (cont)
LM End	6.39	Issue Type +	En	Location *	LS
Category	Supplemental			GPS Latitude/Longitude	
				Start	End
Item	DWR UCIP Field Study			38.290373 °	38.290373 °
				-121.627633 °	-121.627633 °
DWR ID					
Action/Comments					
Inspector Comments: FS_ID:32542					
DS_ID:21059					
EP_NO: N/A					
FS_HLM: 6.5					
Repair Type: Non-Urgent					
Crossing Status: Found

View of waterward side. Dense vegetation along levee slope.

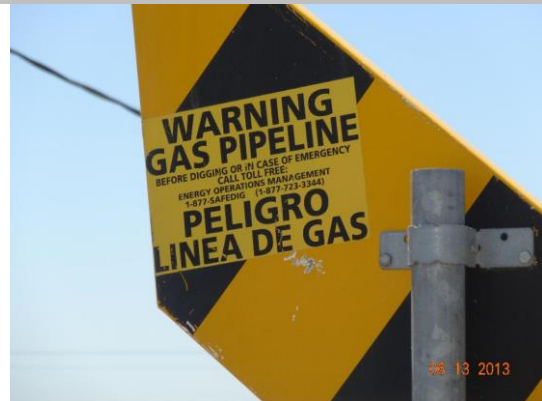
Photo 1 of 3 : UCIP_FA_2015_5962.jpg

LM Start	6.40	Rating **	M	Issue No.	148
LM End	6.40	Issue Type +	En	Location *	LS
Category	Supplemental			GPS Latitude/Longitude	
				Start	End
Item	DWR UCIP Field Study			38.290356 °	38.290356 °
				-121.627488 °	-121.627488 °
DWR ID					
Action/Comments					
Inspector Comments: FS_ID:42118 DS_ID:24054 EP_NO: N/A FS_HLM: 6.51 Repair Type: Non-Urgent Crossing Status: Indicator Found UCIP Comments: Need to determine encroachment number issued for pipe installation. FIELD_STRUCT_DESC: Gasline through levee at an angle with unknown depth. Markers visible on both sides. FS Date: 06/13/2013

Marker with contact information on landward side.

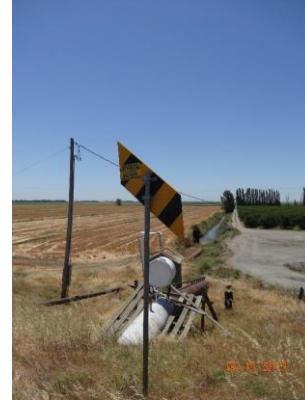
Photo 2 of 3 : UCIP_FA_2015_5963.jpg

LM Start	6.40	Rating **	M	Issue No.	148 (cont)	
LM End	6.40	Issue Type +	En	Location *	LS	
Category	Supplemental			GPS Latitude/Longitude		
				Start	End	
Item	DWR UCIP Field Study			38.290356 °	38.290356 °	
				-121.627488 °	-121.627488 °	
DWR ID						
Action/Comments						
Inspector Comments: FS_ID:42118						
DS_ID:24054						
EP_NO: N/A						
FS_HLM: 6.51						
Repair Type: Non-Urgent						
Crossing Status: Indicator Found						
UCIP Comments: Need to determine encroachment number issued for pipe installation.						
FIELD_STRUCT_DESC: Gasline through levee at an angle with unknown depth. Markers visible on both sides.						
FS Date: 06/13/2013

Marker visible on landward side.

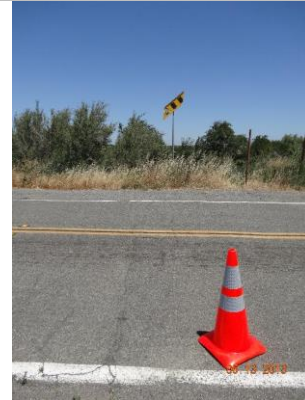
Photo 3 of 3 : UCIP_FA_2015_5964.jpg

Markers visible on waterward side.

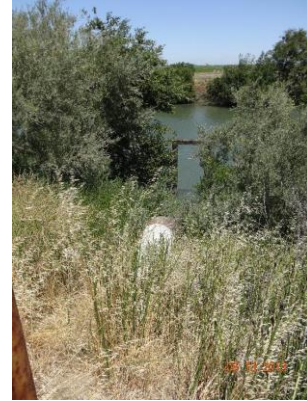
Photo 1 of 3 : UCIP_FA_2015_2069.jpg

LM Start	6.40	Rating **	M	Issue No.	149
LM End	6.40	Issue Type +	En	Location *	LS
Category	Supplemental			GPS Latitude/Longitude	
				Start	End
Item	DWR UCIP Field Study			38.290351 °	38.290351 °
				-121.627452 °	-121.627452 °
DWR ID					
Action/Comments					
Inspector Comments: FS_ID:19668 DS_ID:21057 EP_NO: N/A FS_HLM: 6.514 Repair Type: Non-Urgent Crossing Status: Found

Pipe visible through dense vegetation. Reminiscence of platform located on river.

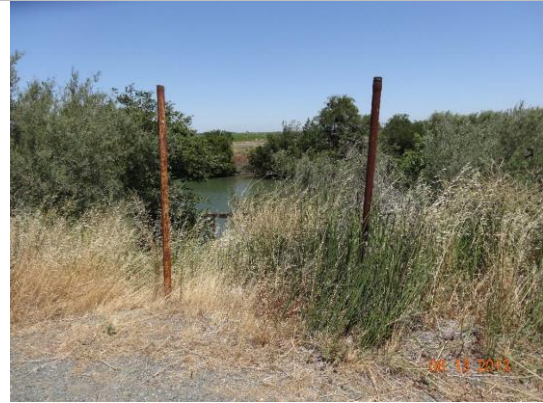
Photo 2 of 3 : UCIP_FA_2015_2070.jpg

View of waterward side. Metal posts near the levee crown.

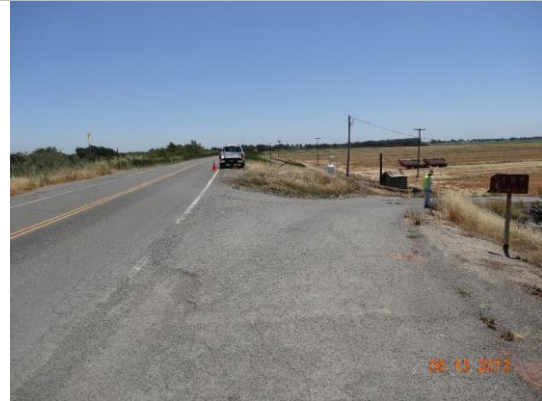
Photo 3 of 3 : UCIP_FA_2015_2085.jpg

Overview of levee crown--multiple crossings within a 50 foot stretch.

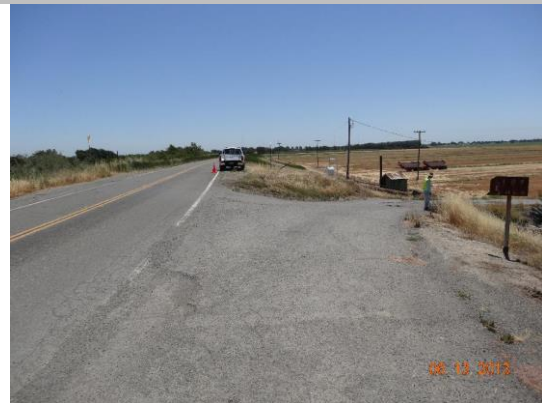
Photo 1 of 3 : UCIP_FA_2015_3129.jpg

LM Start	6.41	Rating **	M	Issue No.	150
LM End	6.41	Issue Type +	En	Location *	LS
Category	Supplemental			GPS Latitude/Longitude	
				Start	End
Item	DWR UCIP Field Study			38.290345 °	38.290345 °
				-121.627401 °	-121.627401 °
DWR ID					
Action/Comments					
Inspector Comments: FS_ID:32543 DS_ID:21058 EP_NO: N/A FS_HLM: 6.52 Repair Type: Non-Urgent Crossing Status: Found UCIP Comments: Dense vegetation limits the inspector's visibility to identify signs of pipe failure (leaks) along the waterward slope. Recommend removing vegetation along pipe alignment to conduct proper inspection of structure and appurtenances. Need to find pipe owner. Unable to determine status of crossing. FIELD_STRUCT_DESC: Abandoned 8-inch steel pipe through the levee, 2.7 feet below the crown. Siphon breaker on apex of pipe at landward shoulder. Surge chamber at landward toe. Pump near waterward toe. Pipe exposed on landward side. (USACE-1959). Concrete platform 4 feet by 3 feet located on landward toe. 3-inch conduit runs along 8-inch steel pipe. This entry matches the Drainage or Irrigation Structure referenced in O&M manual (HLM 6.90). FS Date: 06/13/2013

Overview of levee crown--multiple crossings within 50 foot stretch.

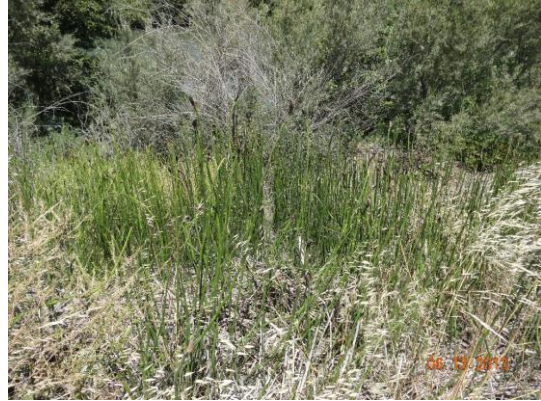
Photo 2 of 3 : UCIP_FA_2015_3130.jpg

Inspector Comments: FS_ID:32543
 DS_ID:21058
 EP_NO: N/A
 FS_HLM: 6.52
 Repair Type: Non-Urgent
 Crossing Status: Found
 UCIP Comments: Dense vegetation limits the inspector's visibility to identify signs of pipe failure (leaks) along the waterward slope. Recommend removing vegetation along pipe alignment to conduct proper inspection of structure and appurtenances. Need to find pipe owner. Unable to determine status of crossing.
 FIELD_STRUCT_DESC: Abandoned 8-inch steel pipe through the levee, 2.7 feet below the crown. Siphon breaker on apex of pipe at landward shoulder. Surge chamber at landward toe. Pump near waterward toe. Pipe exposed on landward side. (USACE-1959). Concrete platform 4 feet by 3 feet located on landward toe. 3-inch conduit runs along 8-inch steel pipe. This entry matches the Drainage or Irrigation Structure referenced in O&M manual (HLM 6.90).
 FS Date: 06/13/2013

View of waterward side. Dense vegetation along levee slope.

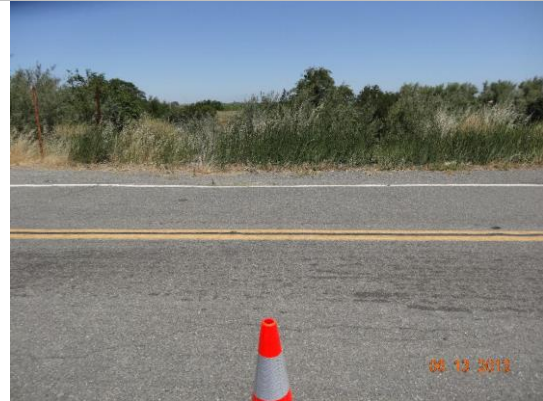
Photo 3 of 3 : UCIP_FA_2015_3131.jpg

View levee crown at crossing.

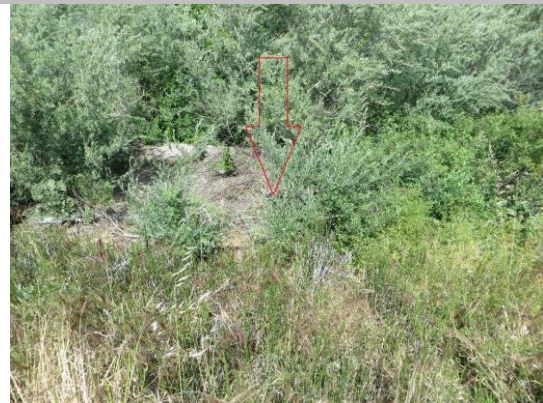
Photo 1 of 2 : UCIP_FA_2015_6258.jpg

LM Start	6.41	Rating **	M	Issue No.	151
LM End	6.41	Issue Type +	En	Location *	LS
Category	Supplemental			GPS Latitude/Longitude	
				Start	End
Item	DWR UCIP Field Study			38.290356 °	38.290356 °
				-121.627349 °	-121.627349 °
DWR ID					
Action/Comments					
Inspector Comments: FS_ID:44748 DS_ID:21027 EP_NO: N/A FS_HLM: 6.52 Repair Type: Non-Urgent Crossing Status: Found UCIP Comments: Pipe appears abandoned and if so should be done so properly. FIELD_STRUCT_DESC: 2 of 2: 4-inch steel pipe through the levee, 7.3 feet below the crown. (USACE-1959). Pipe visible on upstream side of wooden platform of WS slope. This entry matches the Drainage or Irrigation Structure referenced in O&M manual (HLM 6.90). FS Date: 04/23/2015

Pipe visible on upstream side of wooden platform on the WS slope.

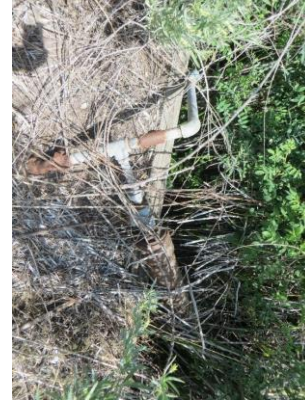
Photo 2 of 2 : UCIP_FA_2015_6259.jpg

4-inch pipe connected to smaller galvanized iron pipe on WS slope.

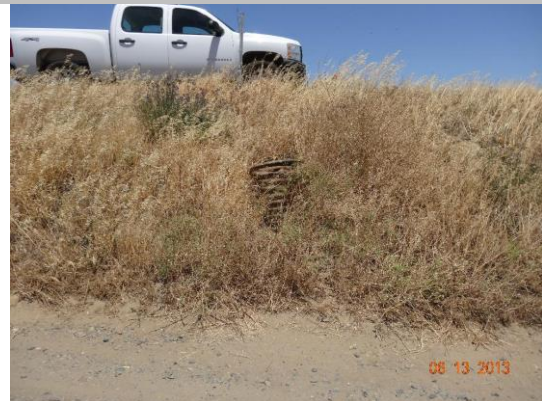
Photo 1 of 4 : UCIP_FA_2015_3132.jpg

LM Start	6.81	Rating **	M	Issue No.	152
LM End	6.81	Issue Type +	En	Location *	LS
Category	Supplemental			GPS Latitude/Longitude	
				Start	End
Item	DWR UCIP Field Study			38.290130 °	38.290130 °
				-121.620168 °	-121.620168 °
DWR ID					
Action/Comments					
Inspector Comments: FS_ID:32544 DS_ID:21060 EP_NO: N/A FS_HLM: 6.928 Repair Type: Non-Urgent Crossing Status: Found UCIP Comments: Dense vegetation limits the inspector's visibility to identify signs of pipe failure (leaks) along the slope. Recommend removing vegetation along pipe alignment to conduct proper inspection of structure and appurtenances. Walkway missing but platform remain on the waterward side. FIELD_STRUCT_DESC: 12-inch pipe through the levee, 6.5 feet below the crown. Switch panel on waterward slope. Pump on pile structure in stream. (USACE-1959). This entry matches the Drainage or Irrigation Structure referenced in O&M manual (HLM 7.30). FS Date: 06/13/2013

Corrugated metal riser located on the landward slope (top portion).

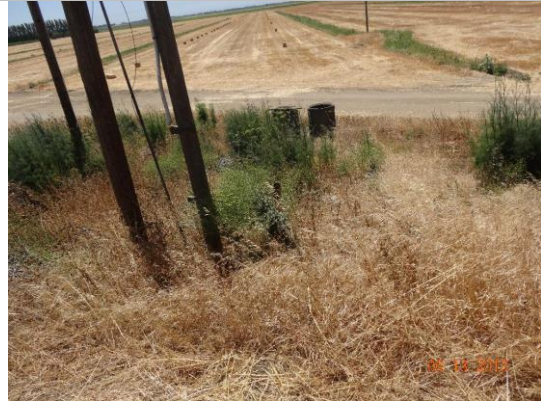
Photo 2 of 4 : UCIP_FA_2015_3133.jpg

View of standpipes located on landward side.

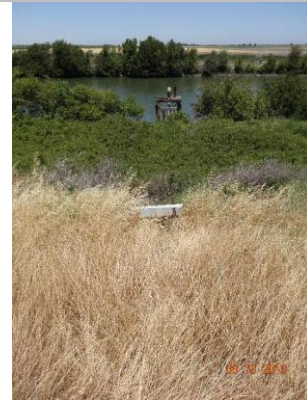
Photo 3 of 4 : UCIP_FA_2015_3134.jpg

View of waterward side. Support piles, conduit line, and pump visible on waterward side. Dense vegetation covers waterward slope.
